**DRAFT  
PRELIMINARY ASSESSMENT REPORT**

**RCRA FACILITY ASSESSMENT  
HYDROCARBON RECYCLERS, INC.  
WICHITA, KANSAS**

Work Assignment No.	:	R07015
USEPA Region	:	7
Date Prepared	:	September 24, 1990
Contract No.	:	68-W9-0006
PRC No.	:	009R07015
Prepared by	:	B&V Waste Science and Technology Corp.
Work Assignment Manager	:	John P. Nett
Telephone No.	:	913/339-2900
USEPA Primary Contract	:	Mark Matthews
Telephone No.	:	913/551-7635

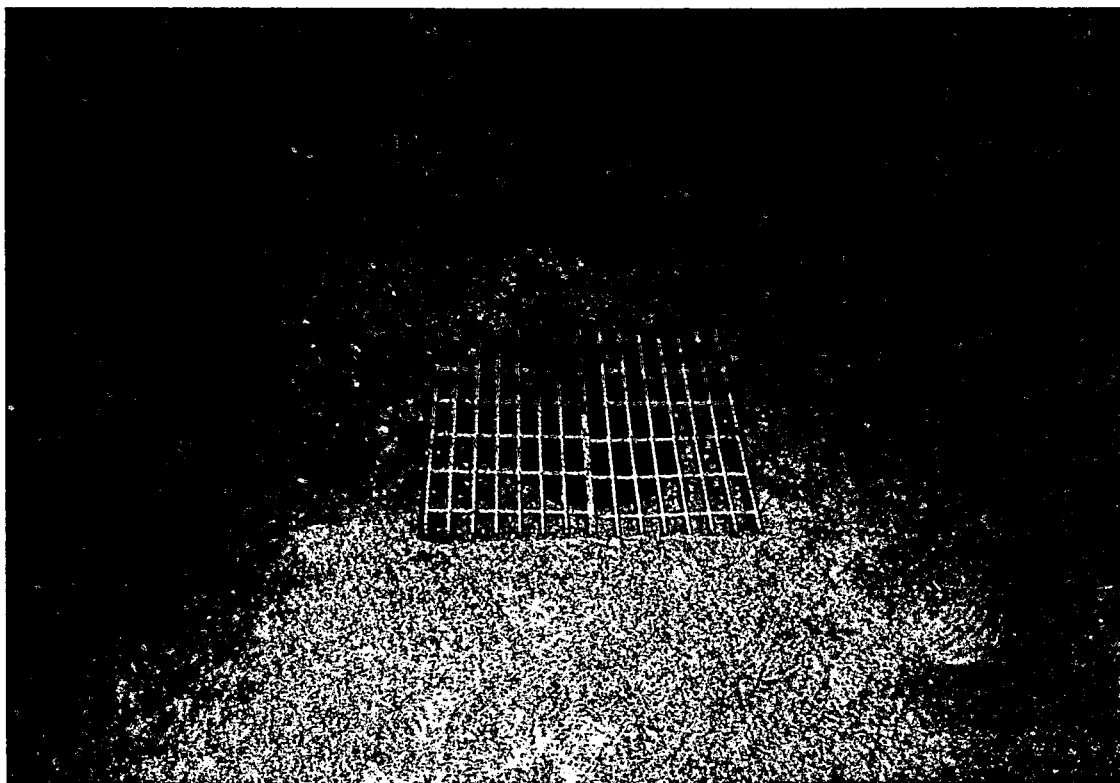
Film Roll No.: 1 Date: 6/19/90 Time: 1012  
 Exposure No.: 13 Photographer: JPN  
 VSI Observations: Sump in elevated tank area, west end of Bldg. D.  
 View - E

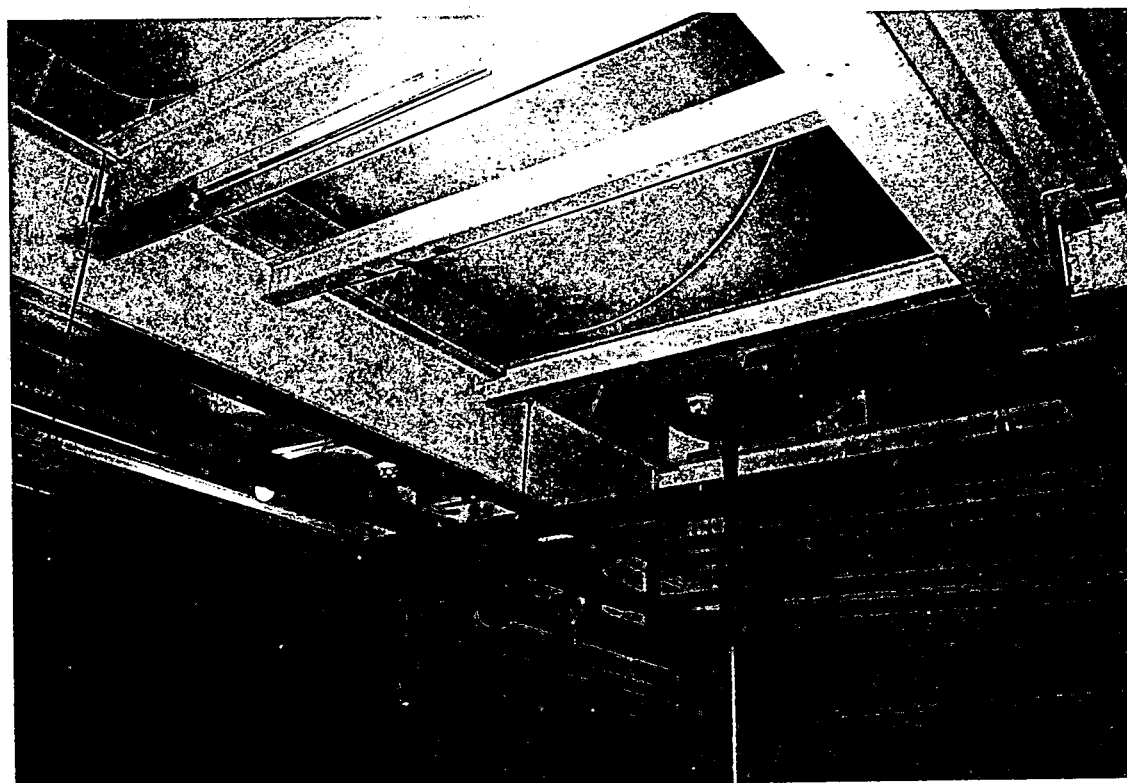
Film Roll No.: 1 Date: 6/19/90 Time: 1015  
 Exposure No.: 14 Photographer: JPN  
 VSI Observations: Elevated storage tanks in Bldg. D. View - SW

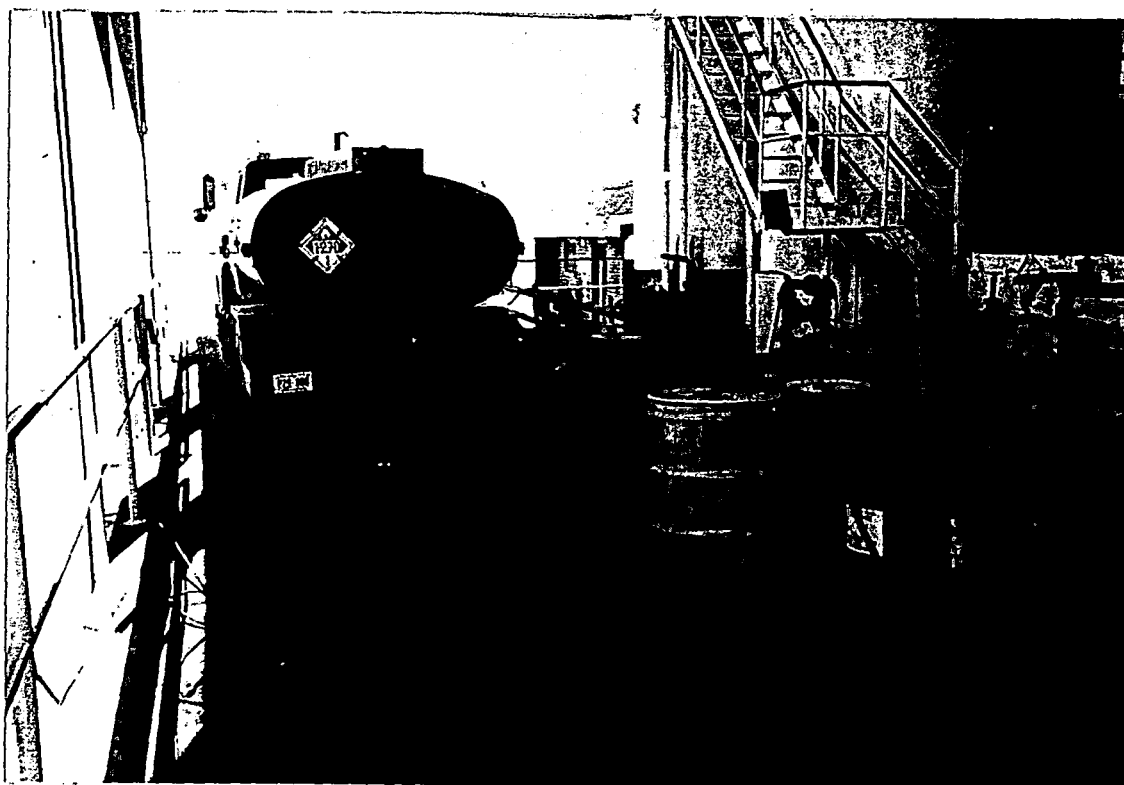
Film Roll No.: 1 Date: 6/19/90 Time: 1025  
Exposure No.: 16 Photographer: JPN  
VSI Observations: Trench drain sump in truck unloading bay, Process Area. View - W

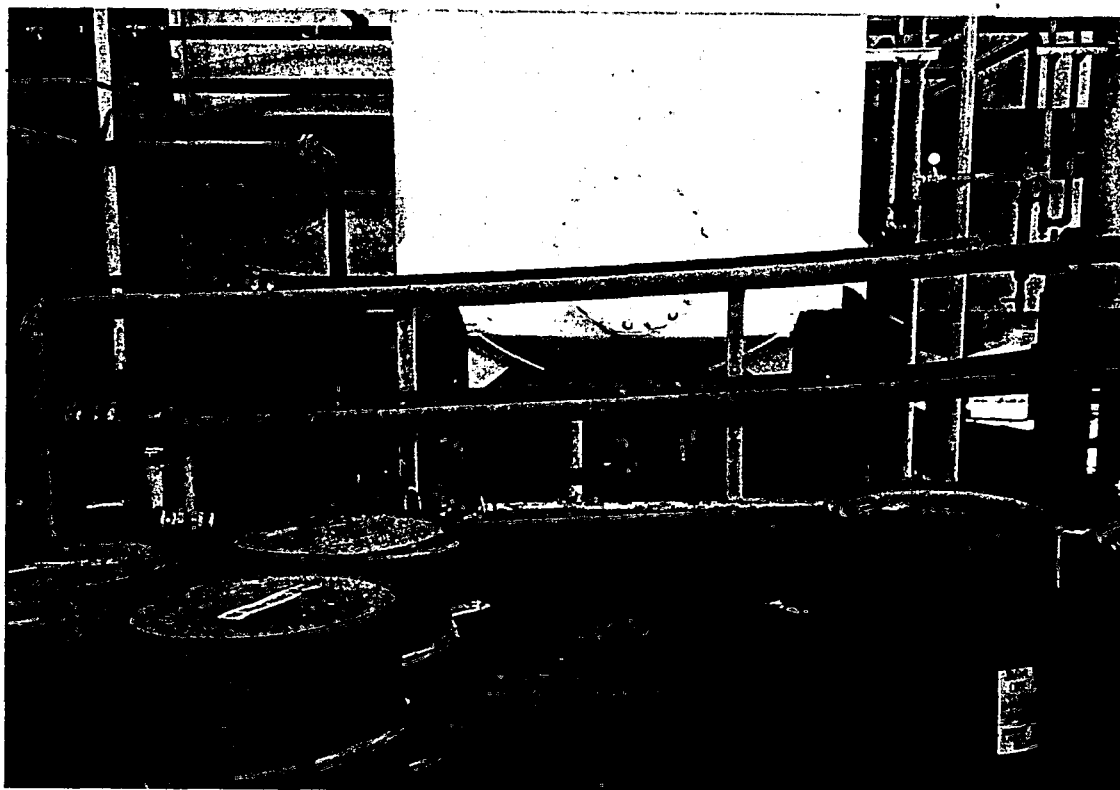
Film Roll No.: 1 Date: 6/19/90 Time: 1025  
 Exposure No.: 17 Photographer: JPN  
 VSI Observations: Storage tanks for flammable wastes, Process Area.  
 View - N

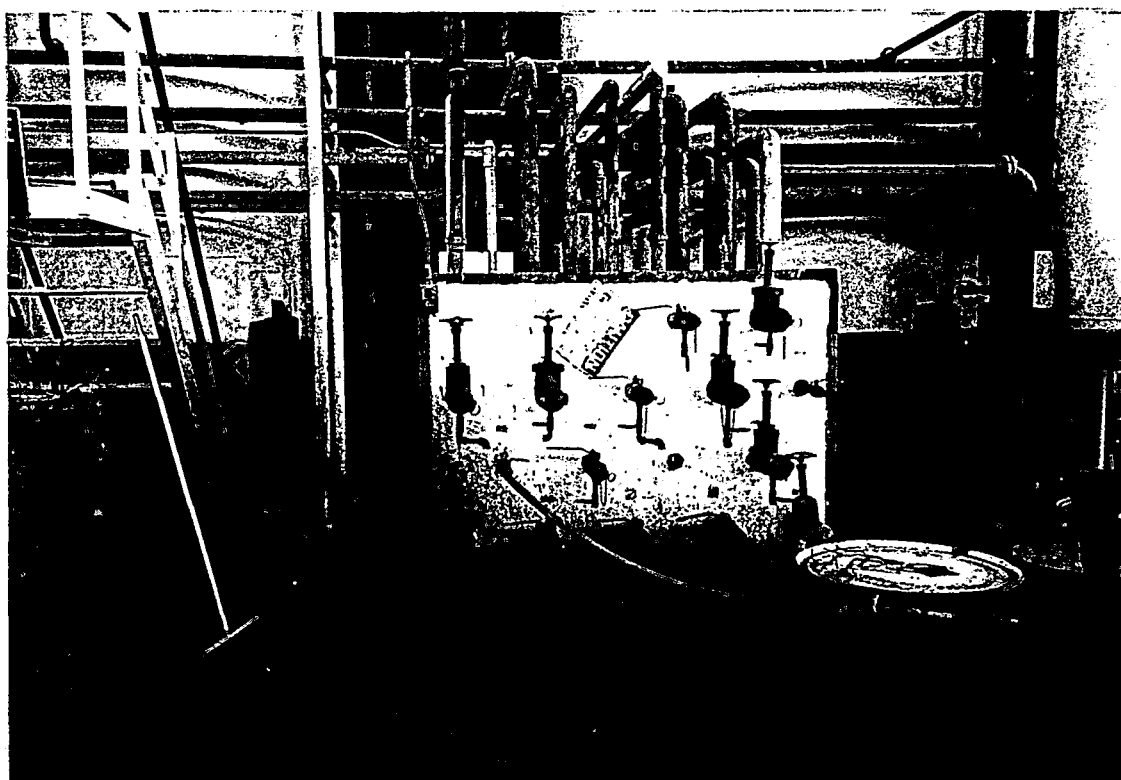
Film Roll No.: 1 Date: 6/19/90 Time: 1025  
 Exposure No.: 18 Photographer: JPN  
 VSI Observations: Manifold for tanker truck loading/unloading to Process  
 Area. View - N

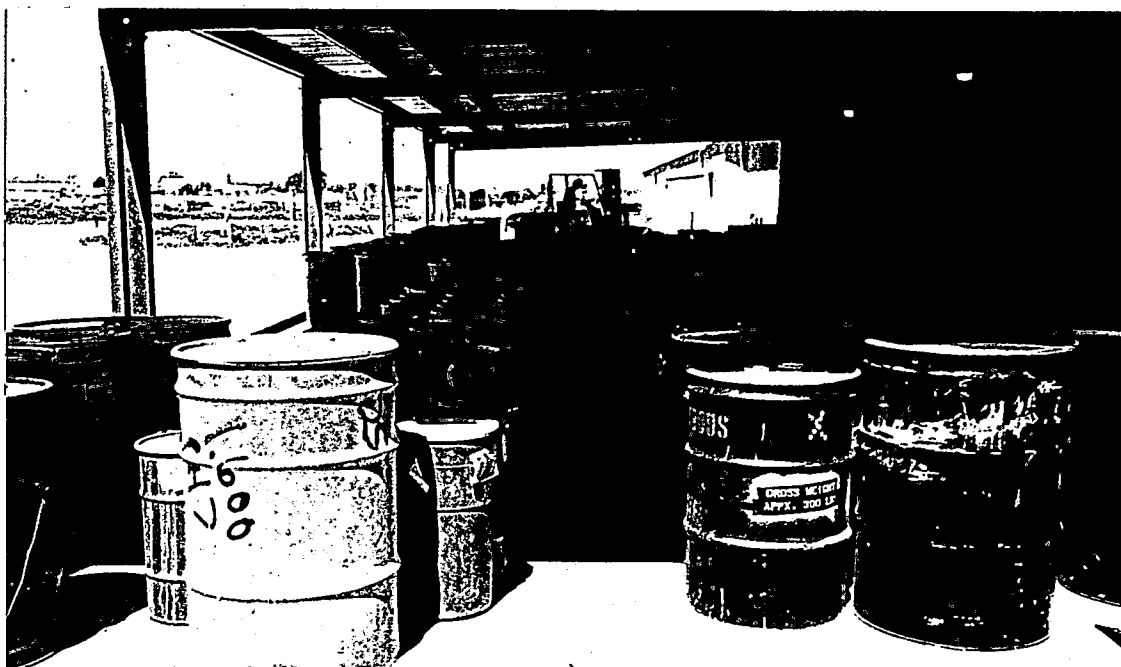
Film Roll No.: 1 Date: 6/19/90 Time: 1030  
 Exposure No.: 19 Photographer: JPN  
 VSI Observations: Drum staging area south side of Bldg. C. View - W

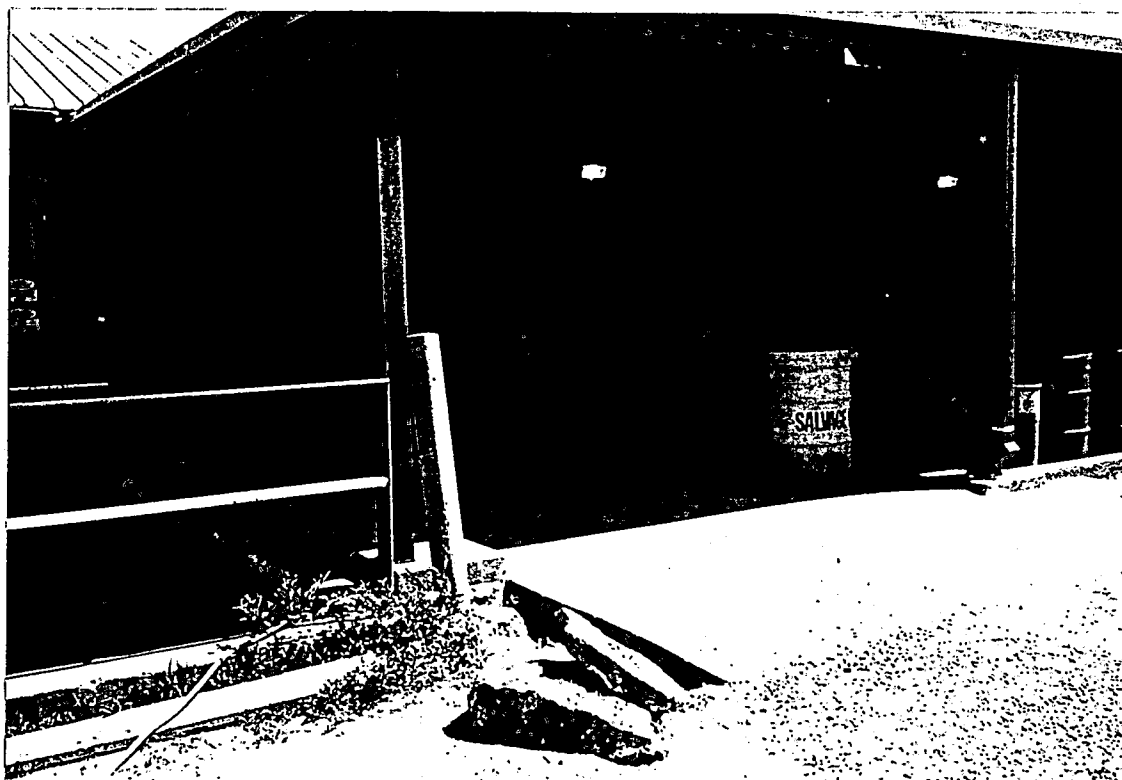
Film Roll No.: 1 Date: 6/19/90 Time: 1030  
 Exposure No.: 20 Photographer: JPN  
 VSI Observations: South central bay, Bldg. C. View - N

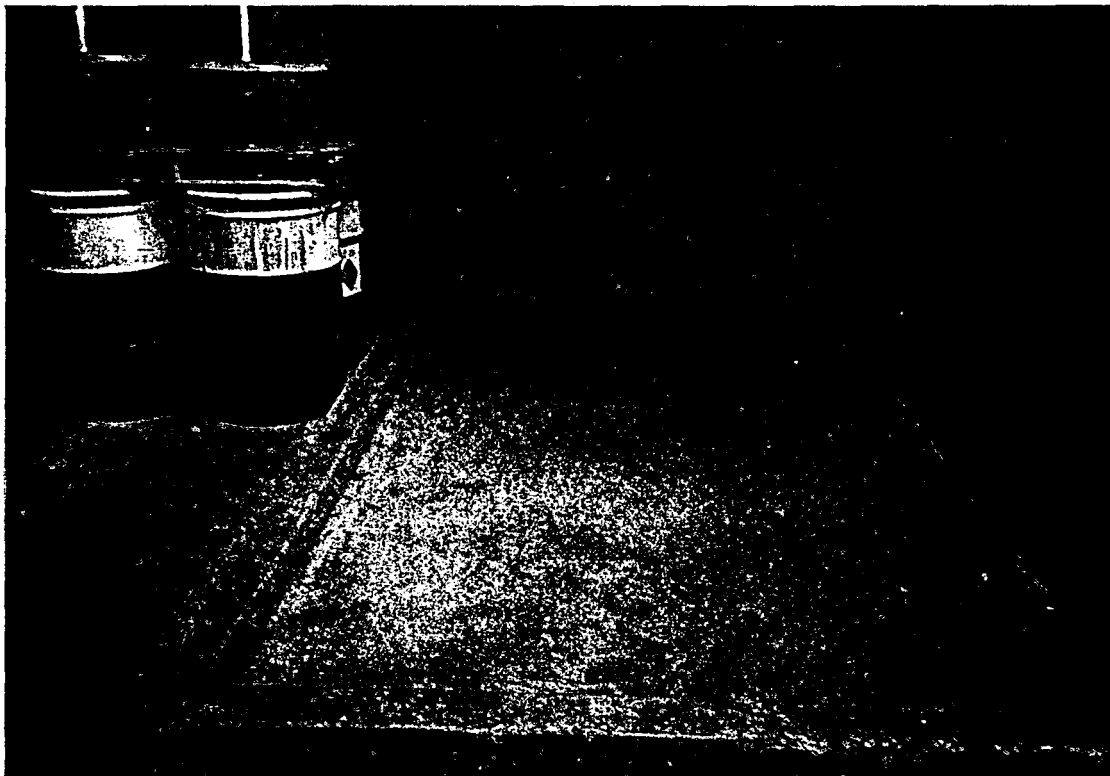
Film Roll No.: 1 Date: 6/19/90 Time: 1040  
Exposure No.: 22 Photographer: JPN  
VSI Observations: Diked incompatible waste storage area, northcentral  
portion of Bldg. C. View - N

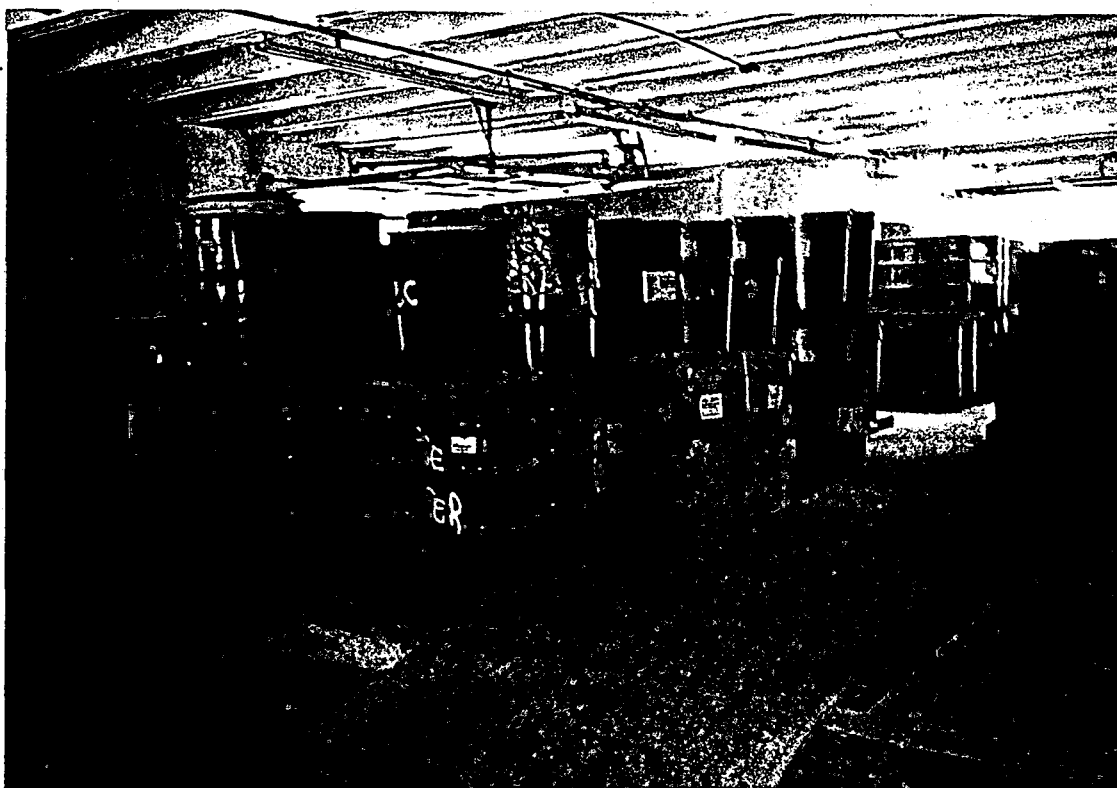
Film Roll No.: 1 Date: 6/19/90 Time: 1042  
 Exposure No.: 23 Photographer: JPN  
 VSI Observations: Incompatible waste storage area, west end of Bldg. C -  
caustic corrosives. View - SW

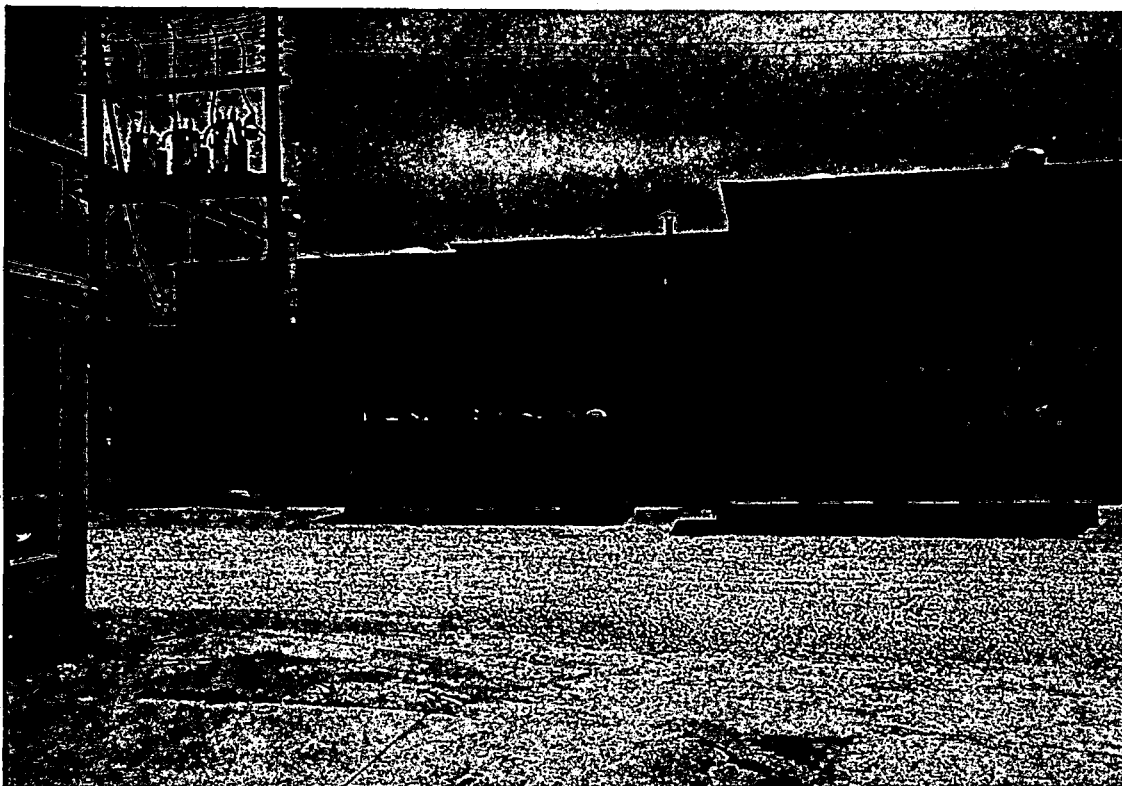
Film Roll No.: 2 Date: 6/19/90 Time: 1120  
 Exposure No.: 2 Photographer: JPN  
 VSI Observations: Two roll-off boxes south of Bldg. D, crushed drum  
storage. View - N

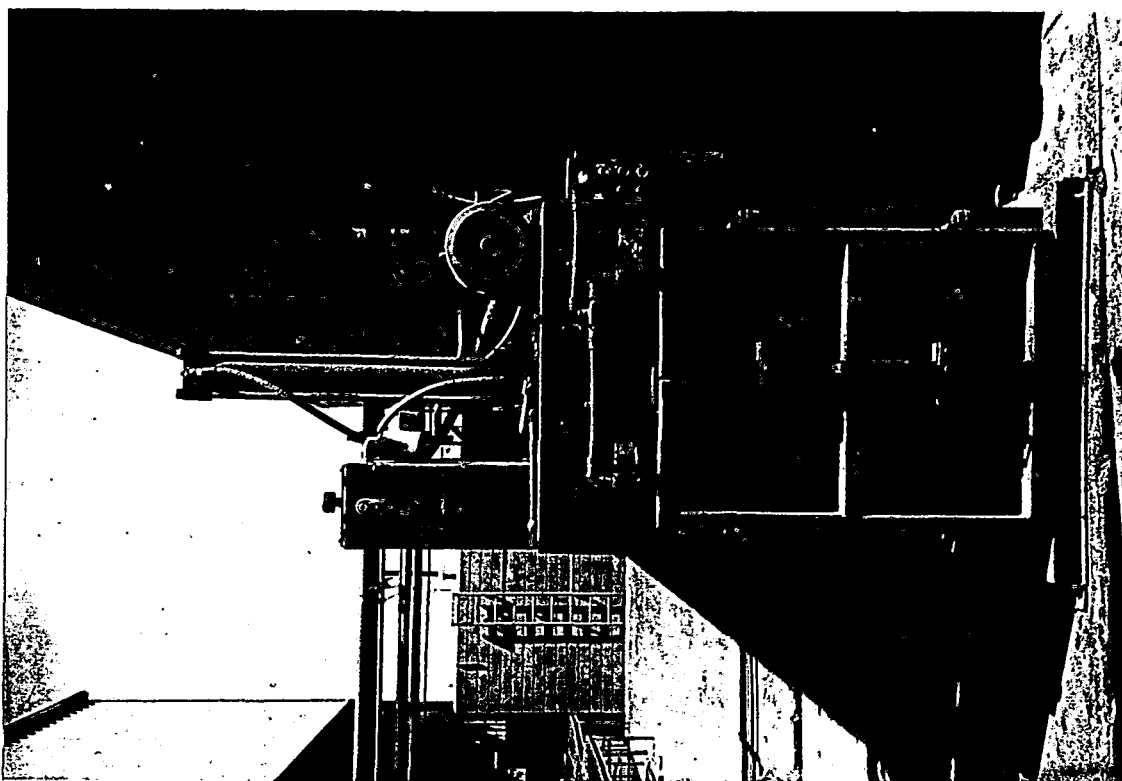
Film Roll No.: 2 Date: 6/19/90 Time: 1125  
 Exposure No.: 3 Photographer: JPN  
 VSI Observations: Drum crusher between Process Area and Bldg. D.  
View - N

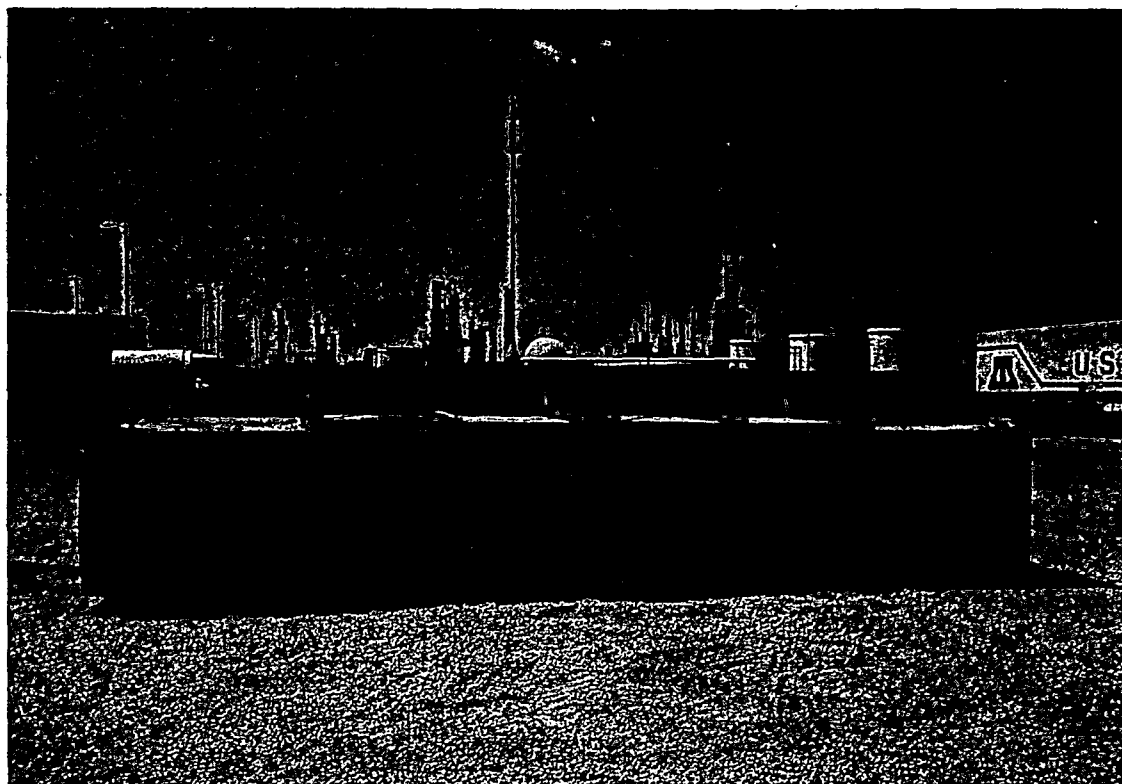
Film Roll No.: 2 Date: 6/19/90 Time: 1135  
 Exposure No.: 4 Photographer: JPN  
 VSI Observations: USPCI gondola for holding (accumulating) dry solids  
wastes (non-land-banned wastes) with vehicle fueling in left background.  
 View - S

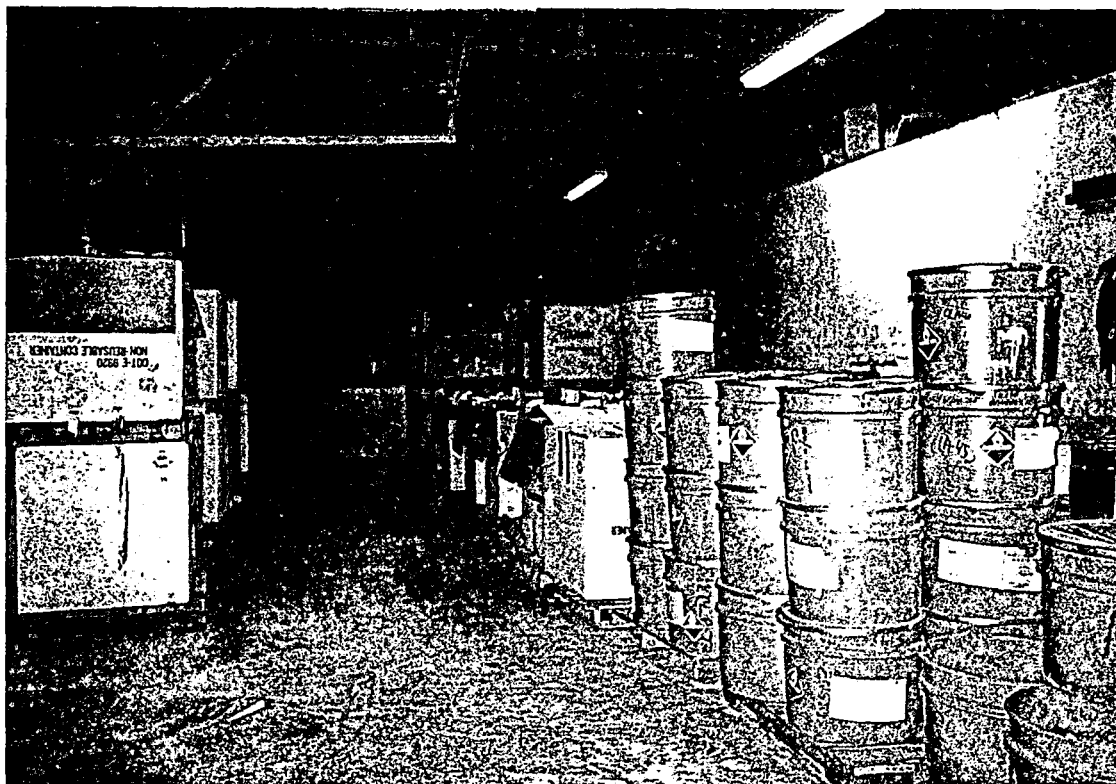
Film Roll No.: 2 Date: 6/19/90 Time: 1345  
 Exposure No.: 10 Photographer: JPN  
 VSI Observations: Household waste collection containers and empty  
containers in Bldg. 18. View - E

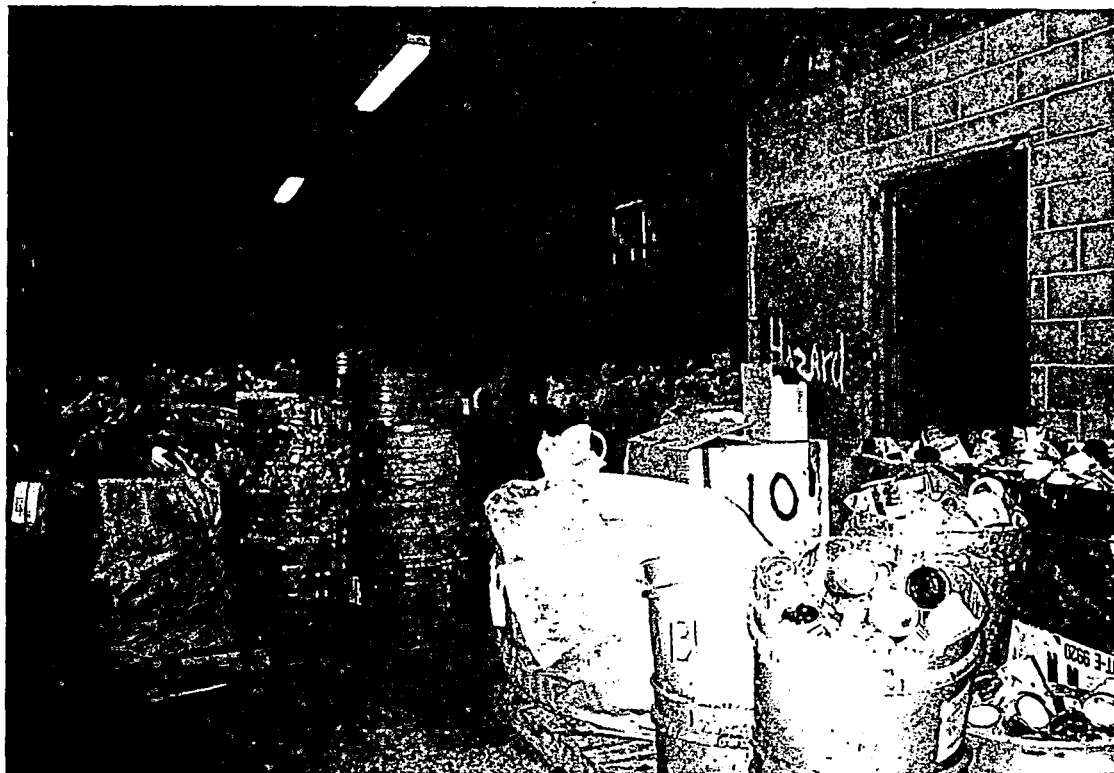
Film Roll No.: 2 Date: 6/19/90 Time: 1350  
 Exposure No.: 11 Photographer: JPN  
 VSI Observations: Household waste collection, 55-gallon lab packed drums  
and bagged containers. View - W

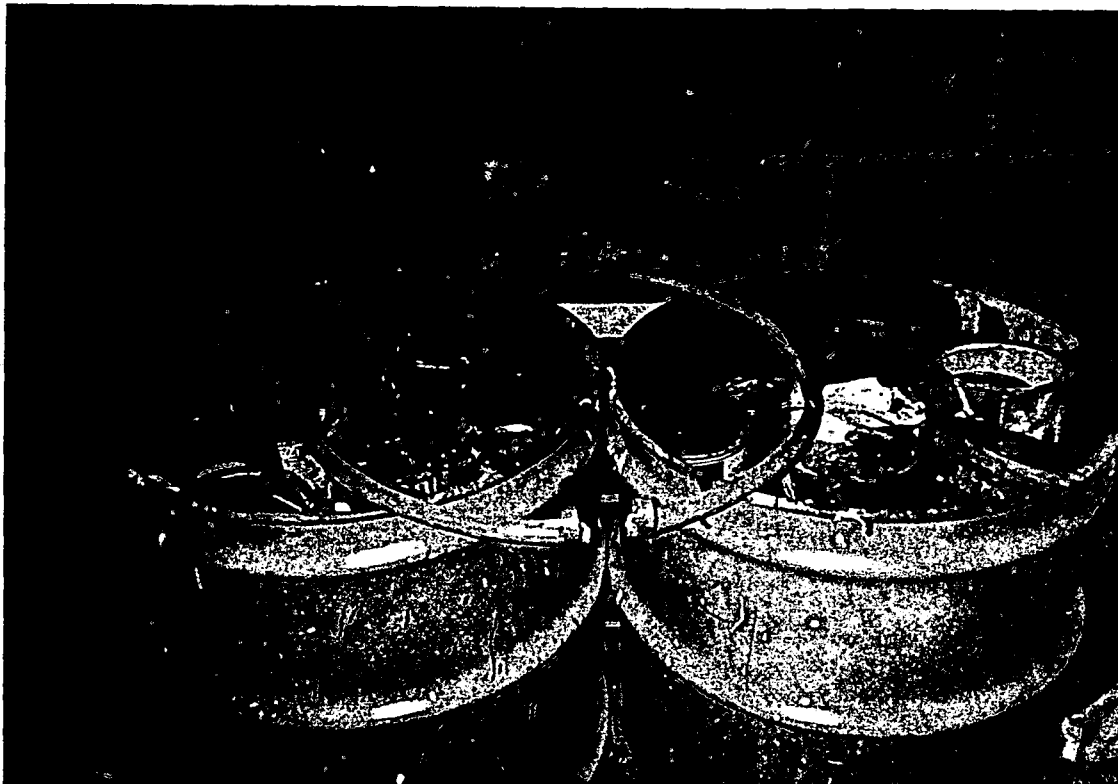
Film Roll No.: 2 Date: 6/19/90 Time: 1350  
 Exposure No.: 12 Photographer: JPN  
 VSI Observations: Open 55-gallon drums containing household waste  
collection empty containers. View - N

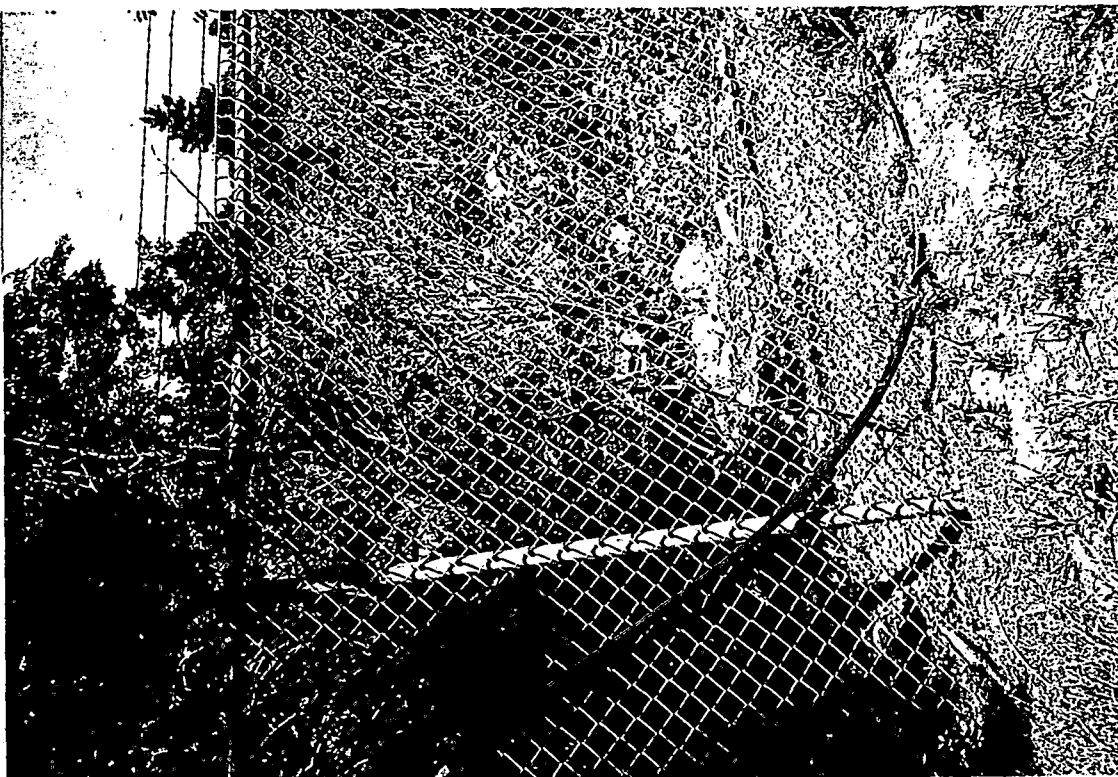
Film Roll No.: 2 Date: 6/19/90 Time: 1410  
 Exposure No.: 13 Photographer: JPN  
 VSI Observations: Drainageway between Service Chemical Supply Co. property  
and Union Pacific RR property. (Note surface staining in foreground).  
View - N

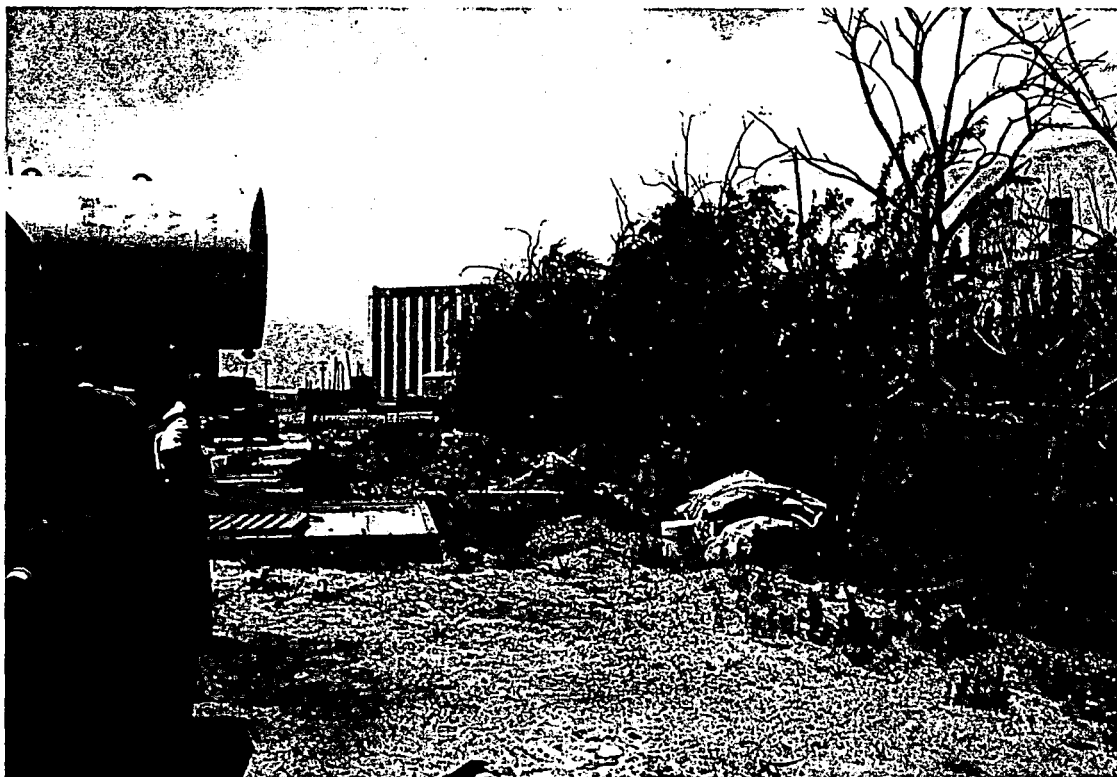
Film Roll No.: 2 Date: 6/19/90 Time: 1415  
 Exposure No.: 15 Photographer: JPN  
 VSI Observations: Fence line between SCSC and drainageway.  
View - NW to N

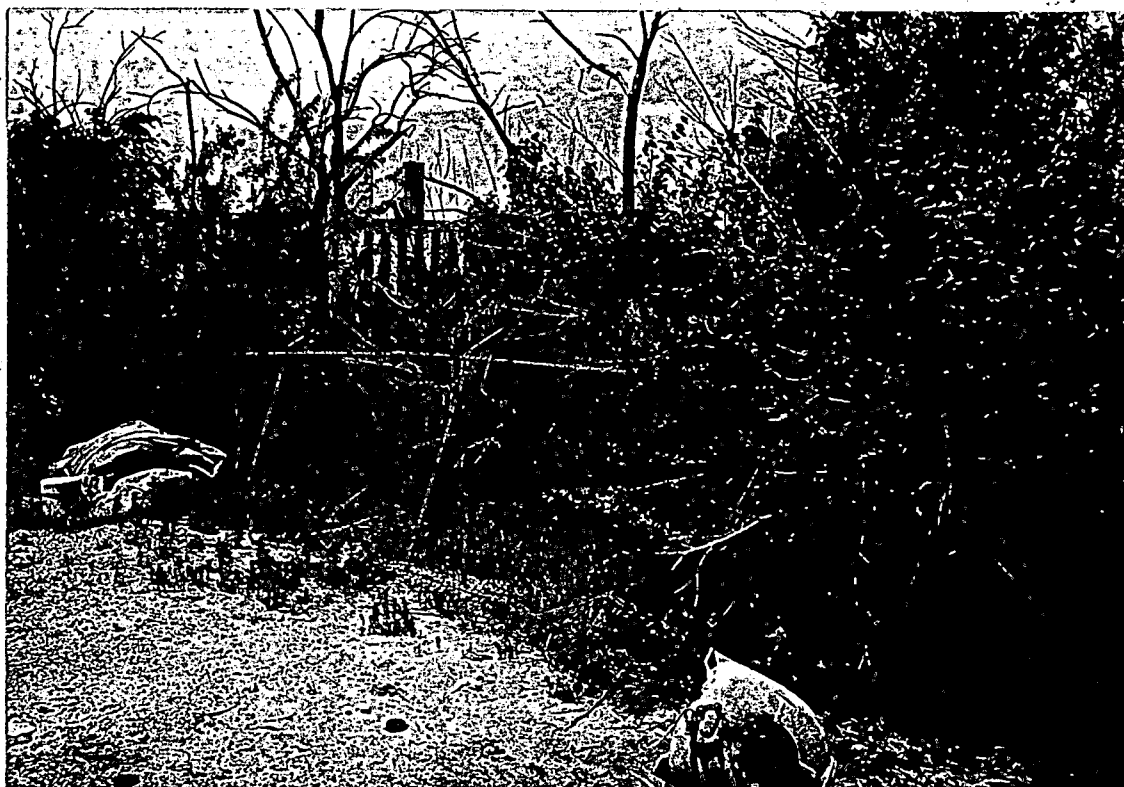
Film Roll No.: 2 Date: 6/19/90 Time: 1415  
 Exposure No.: 16 Photographer: JPN  
 VSI Observation: Fence line between SCSC property and drainageway. View  
- NW to N

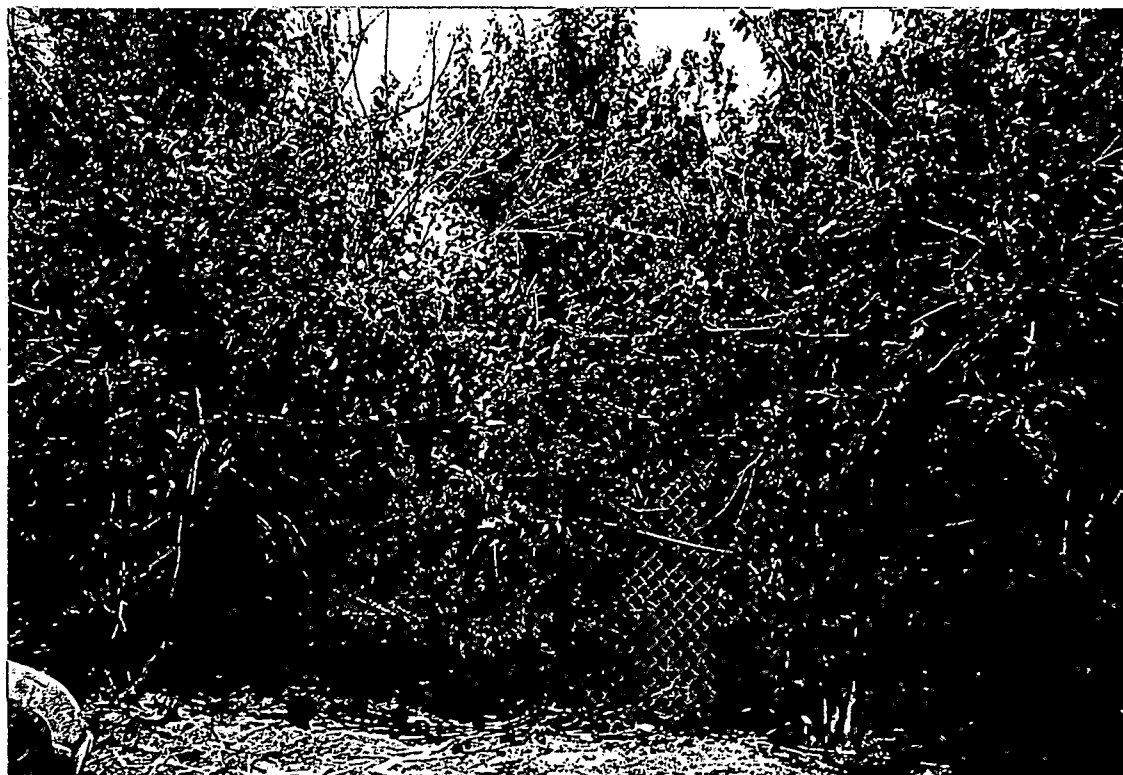
Film Roll No.: 2 Date: 6/19/90 Time: 1415  
 Exposure No.: 17 Photographer: JPN  
 VSI Observation: Fence line between SCS and drainage way. View - NW to N

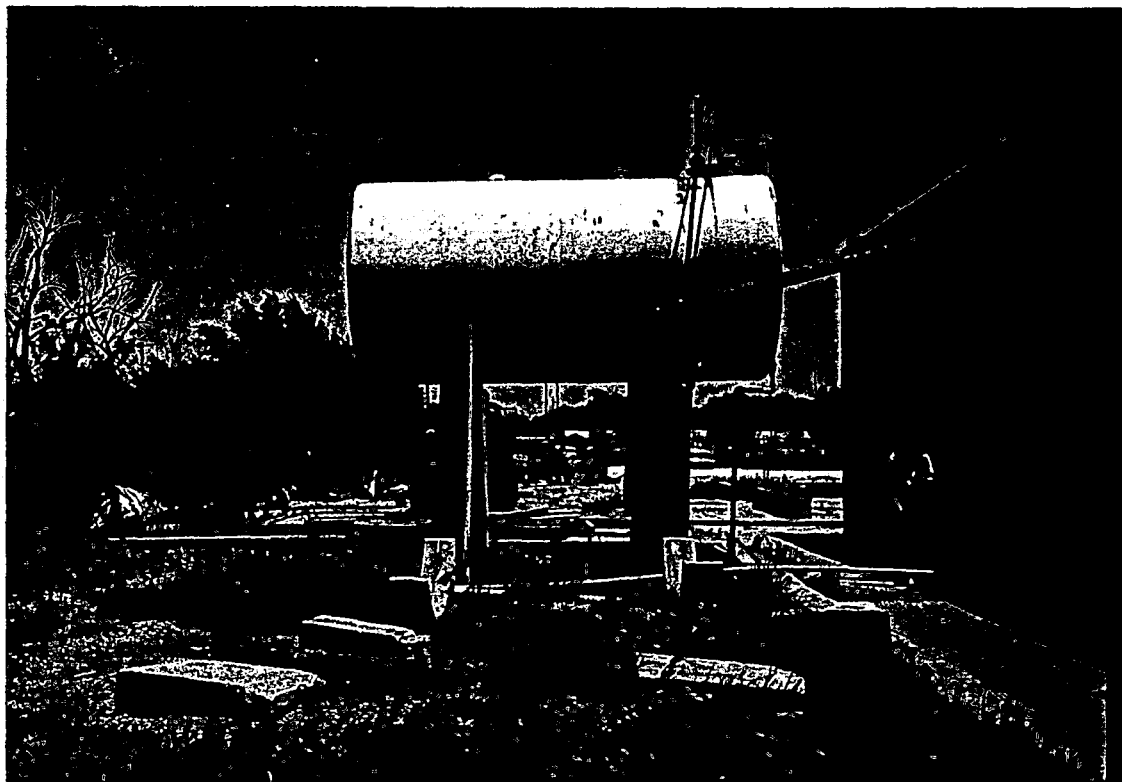
Film Roll No.: 2 Date: 6/19/90 Time: 1420  
 Exposure No.: 18 Photographer: JPN  
 VSI Observations: Out-of-service muriatic acid storage tank; previously  
pipd into acid repackaging area inside Bldg. 17. Tank now empty. View - E
